# Manhole Inspection Summary

Manhole # **S13MM\_046MH**

Insp Date: **9/4/07 5:22 PM**

**Location** Address: **2137 KOKO LN**

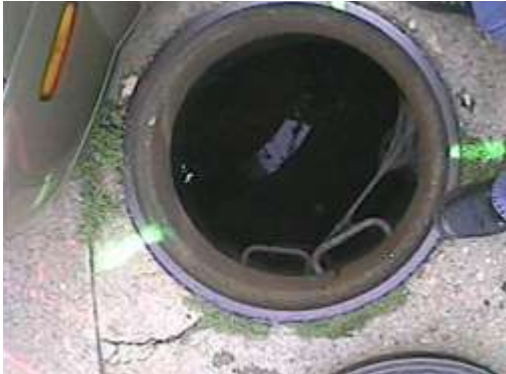
Defect 1

Count: **4** Missing: **0** ☒ **Corroded**

CORRODED STEPS

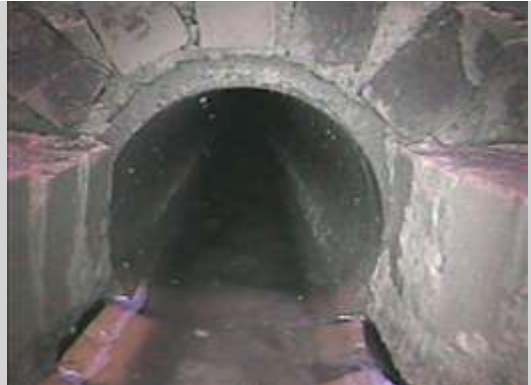
12 O'Clock Outflow

8 in. Circular Gravity Sewer  
Pipe Out @ 12 O'Clock

Pipe Height: (in.) Direct  
Pipe Material: **Clay** ☐ Pipe Lined  
Invert Depth: **7.63** (ft.) Flow Characteristics: **Slow**  
Deposits: ☒ None ☐ Mud ☐ Sludge ☐ Debris ☐ Grease  
Silt Depth: (in.) Deposits Extent:  
Infiltration: **None** Pipe Seal Cond: **Sound**

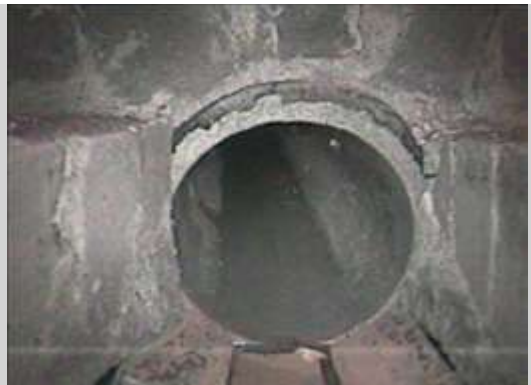
3 O'Clock Inflow

6 in. Circular Gravity Sewer  
Pipe In @ 3 O'Clock

Pipe Height: (in.) Direct  
Pipe Material: **Clay** ☐ Pipe Lined  
Invert Depth: **7.61** (ft.) Flow Characteristics: **Slow**  
Deposits: ☒ None ☐ Mud ☐ Sludge ☐ Debris ☐ Grease  
Silt Depth: (in.) Deposits Extent:  
Infiltration: **None** Pipe Seal Cond: **Broken**

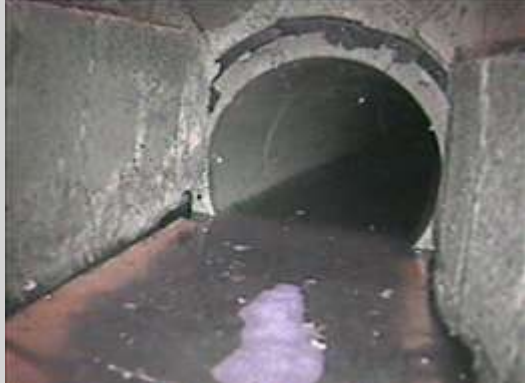
8 O'Clock Inflow

6 in. Circular Gravity Sewer

Pipe In @ 8 O'Clock

Pipe Seal Cond: **Broken**
